## CLINICAL REPORT

# Titanium implant wear from a zirconia custom abutment: A clinical report

This clinical report describes damage to a 1-piece zirconia abutment where both biological and mechanical complications developed, resulting in premature loss of the implant. Scanning electron microscopy showed significant damage to the internal connection of the implant. When using 1-piece zirconia abutments with a titanium internal connection, periodic recall and identification of wear is necessary, especially in patients with repeated screw loosening. (*J Prosthet Dent* 2019;■:■-■)

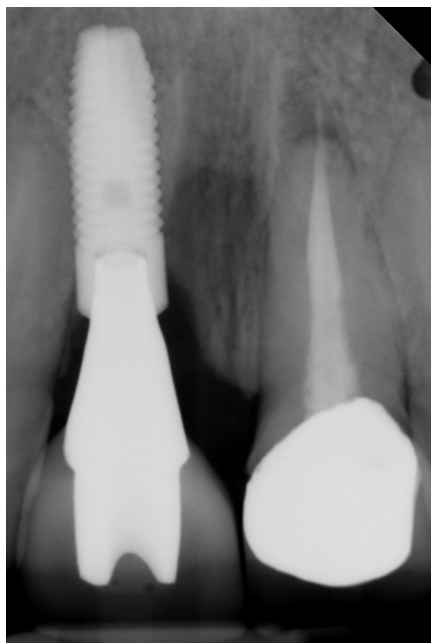
**Figure 1.** Preoperative periapical radiograph showing 1-piece zirconia abutment.

was nonsignificant, and according to the American Society of Anesthesiologists, she was classified as American Society of Anesthesiologists grade I. After careful clinical examination, she was diagnosed with peri-implant mucositis and a loosened implant-supported crown on the right maxillary central incisor. The tooth had been lost as a result of trauma and replaced by an endosseous dental implant (4.0×13 mm Astra OsseoSpeed; Dentsply Sirona), followed by immediate placement of an interim restoration 3 years previously. Six months later, a cement-retained, implant-supported ceramic crown (e.max; Ivoclar Vivadent AG) was fabricated as the definitive restoration on a 1-piece zirconia custom abutment (Atlantis; Dentsply Sirona) and cemented with a zinc oxide non-eugenol temporary cement (Temp-Bond NE; Kerr Corp) (Fig. 1). The patient did not comply with periodic recall appointments.

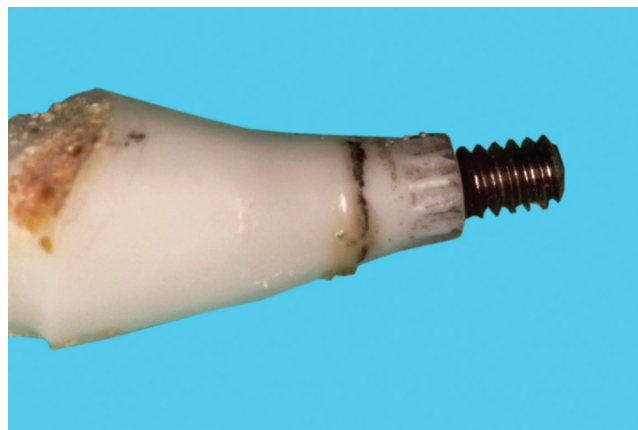
Two years later, the patient presented with the implant crown that had been loose for “quite some time” and had been retightened multiple times by a dentist in private practice. The decision was made to remove the crown to access the screw and better evaluate the clinical condition. The patient was informed of the possibility of the ceramic crown fracturing, and an impression was made of the maxillary teeth. A crown remover (GC Plier; GC America) was used, and upon removal, the crown fractured. The 1-piece zirconia abutment, however, remained intact and was removed for evaluation. The zirconia connection showed significant discoloration and had visible titanium particles embedded (Fig. 2). A transmucosal healing abutment was placed, and an

**Figure 2.** Worn implant abutment with staining and titanium particles embedded.

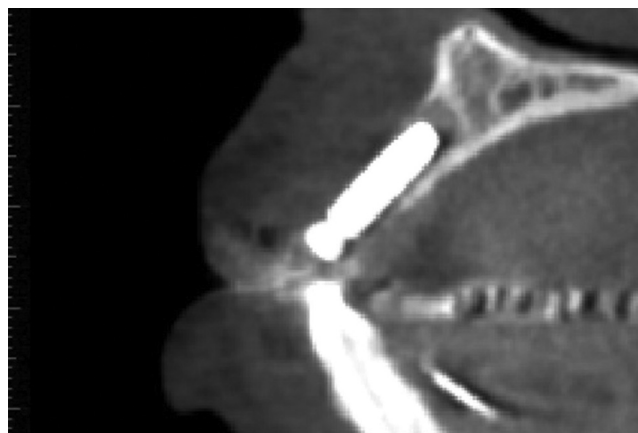
**Figure 3.** Cone-beam computed tomography image showing lack of facial bone and loss of osseointegration.

The CBCT scan confirmed the diagnosis and revealed a significantly patent nasopalatine canal in close proximity to the implant threads, as well as a lack of facial bone (Fig. 3). Owing to the significant alveolar bone loss, an explantation procedure with simultaneous guided bone regeneration was suggested and completed using

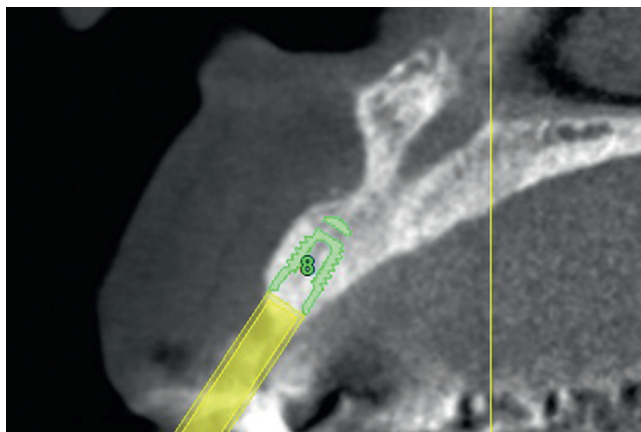
**Figure 4.** Cone-beam computed tomography image made after grafting showing proposed implant placement.

1.5 mL of hydrated freeze-dried bone allograft (AlloGraft; Straumann USA) and a resorbable collagen membrane (BioMend Extend; Zimmer Biomet Dental). Healing progressed without complications. Six months later, another CBCT was ordered to evaluate the grafted site and plan the surgical implant placement. Because of anatomical limitations, a 3.7×8.0-mm endosseous implant was selected and placed without complication (TSV; Zimmer Biomet Dental) (Fig. 4).

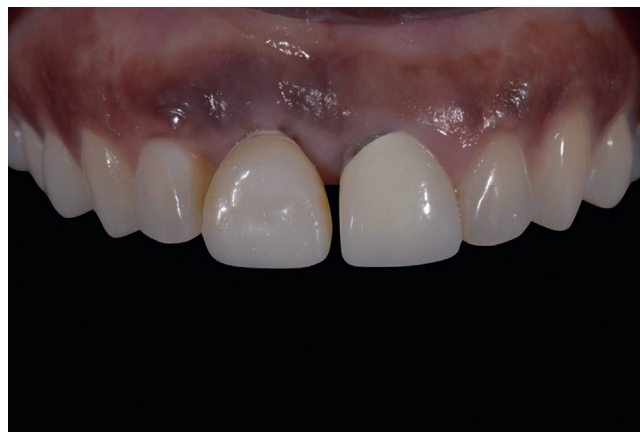
**Figure 5.** Intraoral view of unfavorable proportions and poor esthetics.

Four months after the surgery, the implant was uncovered, and a new interim crown was fabricated to develop the peri-implant soft tissue contours. The interim crown had unfavorable proportions, and as a result, the adjacent crown on the left maxillary central incisor was planned for replacement to improve esthetics (Fig. 5). The existing metal-ceramic crown was removed, and new interim restorations were fabricated using autopolymerized polymethyl methacrylate (Jet Acrylic; Lang Dental Manufacturing Co). Once the patient approved the esthetics, an open-tray impression with a customized transfer coping was made for the

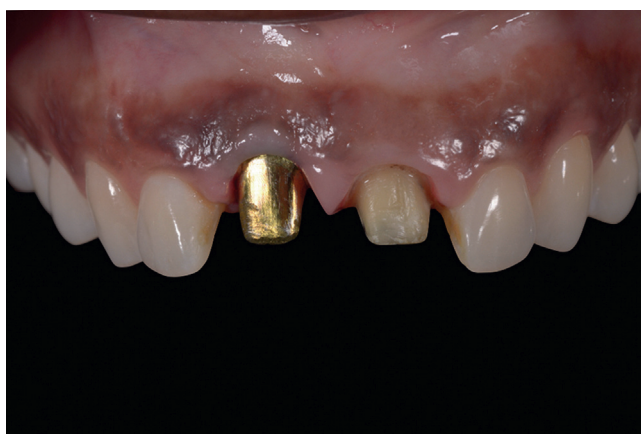
**Figure 6.** Intraoral view of gold-hue titanium abutment and preparation on adjacent tooth.

implant restoration. A gold-hue custom titanium abutment was designed and milled to follow the soft tissue contours and optimize esthetics, and 2 zirconia ceramic crowns (Beyond Zircona; ORIGIN and VM9 porcelain; Vita) were fabricated. The abutment was evaluated clinically and tightened to 30 Ncm following manufacturer recommendations (Fig. 6). The definitive restorations were then evaluated for proximal contacts, fit, occlusion, and esthetics. The implant-supported crown was cemented using interim cement (TNE; Temrex Corp), whereas the tooth-supported crown was cemented with self-adhesive, autopolymerized resin cement (SpeedCEM Plus; Ivoclar Vivadent AG) (Fig. 7).

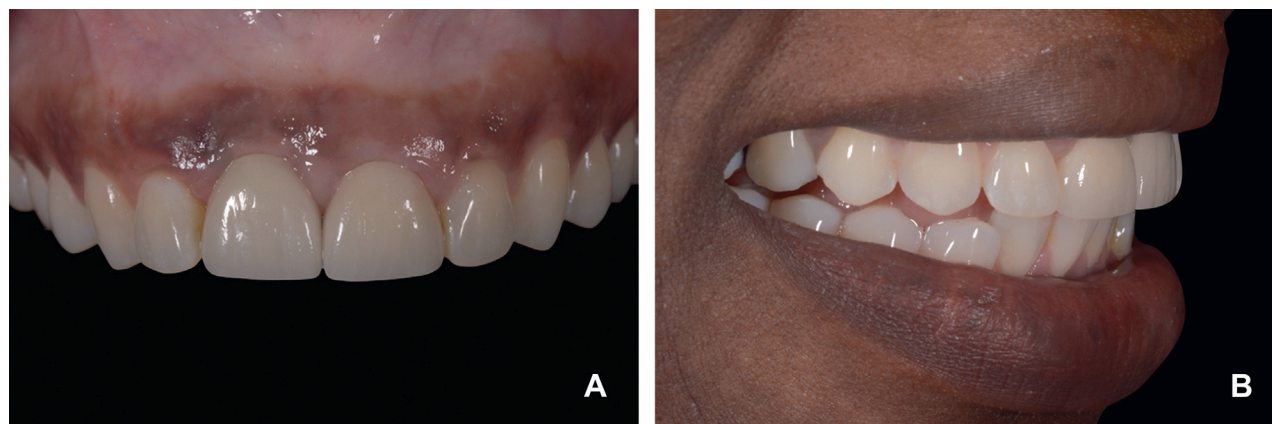
**Figure 7.** Definitive restorations. A, Intraoral view. B, Extraoral view.

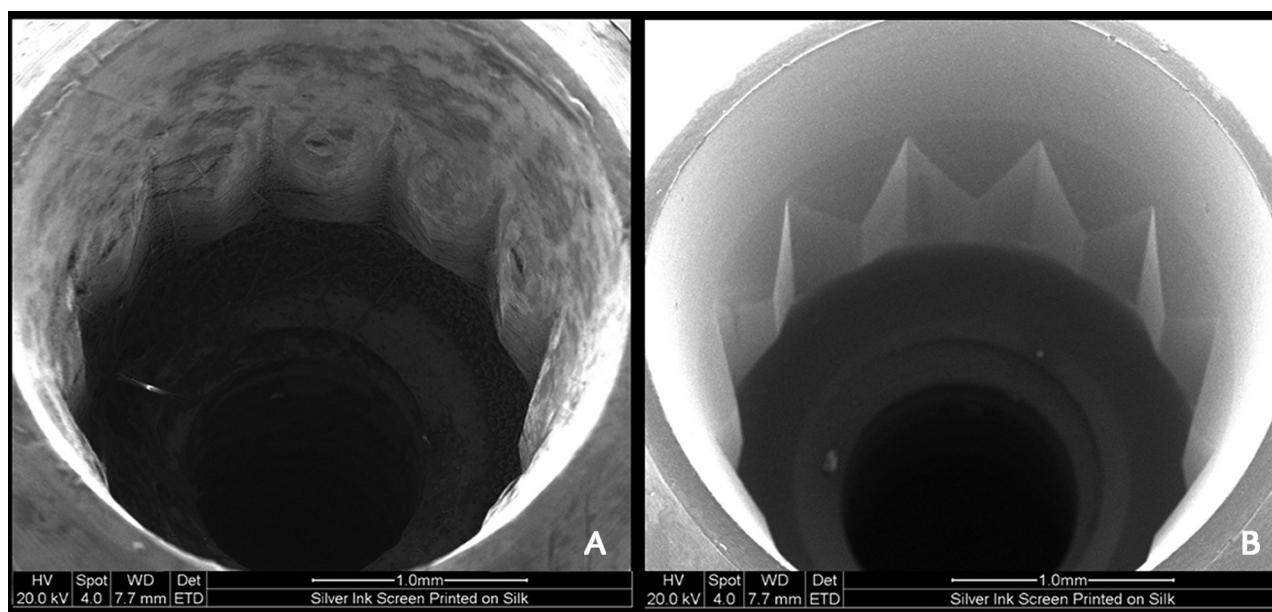
To assess what had occurred on the internal connection of the original failed implant, the implant was retrieved and embedded in orthodontic resin. A scanning electron microscope was used to visualize the surface at 100-μm level. The scanning electron microscope image showed significant surface changes in the hexagonal configuration of the internal connection where the angled surface of the implant was rounded along with surface indentations on the walls (Fig. 8).

**Figure 8.** Scanning electron microscope images. A, Worn internal surface of failed implant. B, Unused implant fixture at 100-μm level.
